Monitoring Data Record

Project Title: I-306 DB (I-85 in Durham) COE Action ID: 200020902
 Stream Name: South Ellerbee Creek (Sites 2 & 13) DWQ Number: 001040
 City, County and other Location Information: I-85 from W. of Broad St. to W. of Camden Ave. in Durham County
 Date Construction Completed: n/a Monitoring Quarter: (4) of 4
 Ecoregion: _____ 8 digit HUC unit 03020201
 USGS Quad Name and Coordinates: _____

South Ellerbee Creek

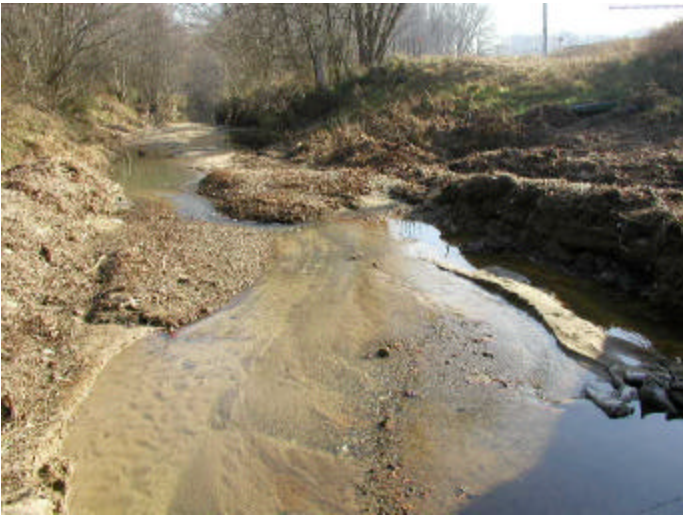
PP #15 Downstream (STA. 1+240 –CONAB- LT.)

The streambanks are stabilized throughout South Ellerbee Creek. There are some areas of localized bank erosion but these areas have stabilized with vegetation. The beaver dams that were noted last monitoring quarter at Sta. 4+800-L- LT. and Sta. 1+020-CONAB- LT. have been removed. Beaver activity is still noted near Sta. 4+620-L- LT. The channel stability and cross vane near Sta. 5+480 LT. was reviewed by DOT, USACE, and DWQ during October 2006. They agreed that the section of stream was stable and does not require the use of rip rap and that the cross vane, although slightly damaged, is still performing the required functions and no remedial action is necessary. The sheet pilings located near Sta. 1+240-CONAB- LT. have been removed.
